# BULLETIN

# THE BREAKERS PLAZA CONDOMINIUM COMPLEX

BY JOHN WEISBARTH

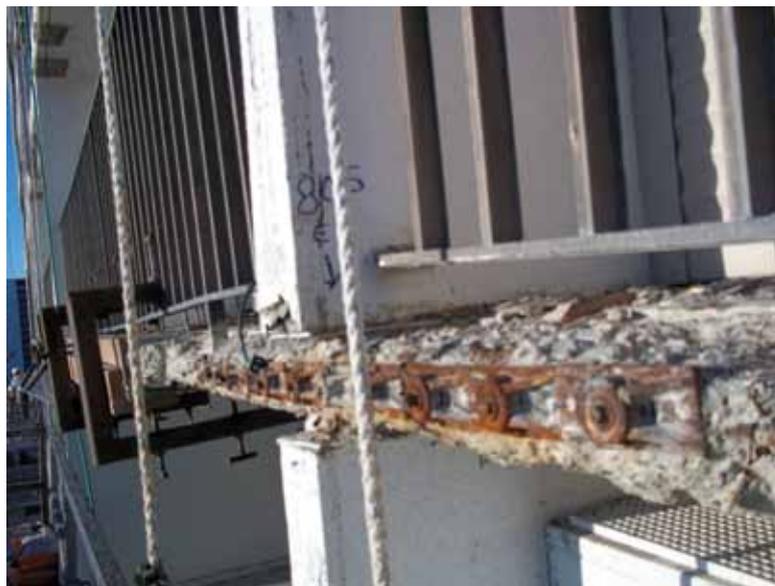
almost all of the post-tensioned anchors were corroded. Many of the balcony edges had cracking.

*Corroded post-tensioned anchors*

Once the deteriorated concrete was removed, the contractor treated or replaced any damaged reinforcing steel. Most of the balcony edge steel that was situated in the post-tensioned anchor zone needed to be replaced. Special custom-made forms and clamps were used to reduce the time required to erect shoring for each balcony.

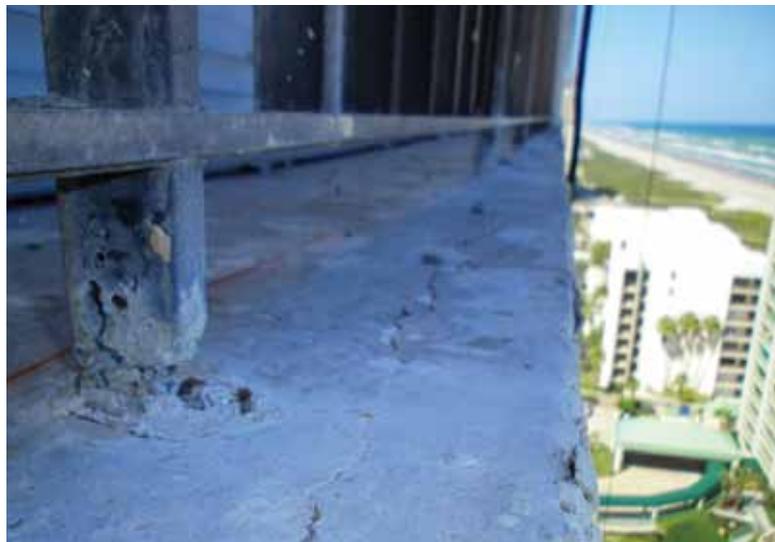
Both directions of the two-way post-tensioned slab had deterioration. Care needed to be taken when replacing the metal balcony railings so the post-tensioned cables would not be damaged.

*Deteriorated balcony slabs*

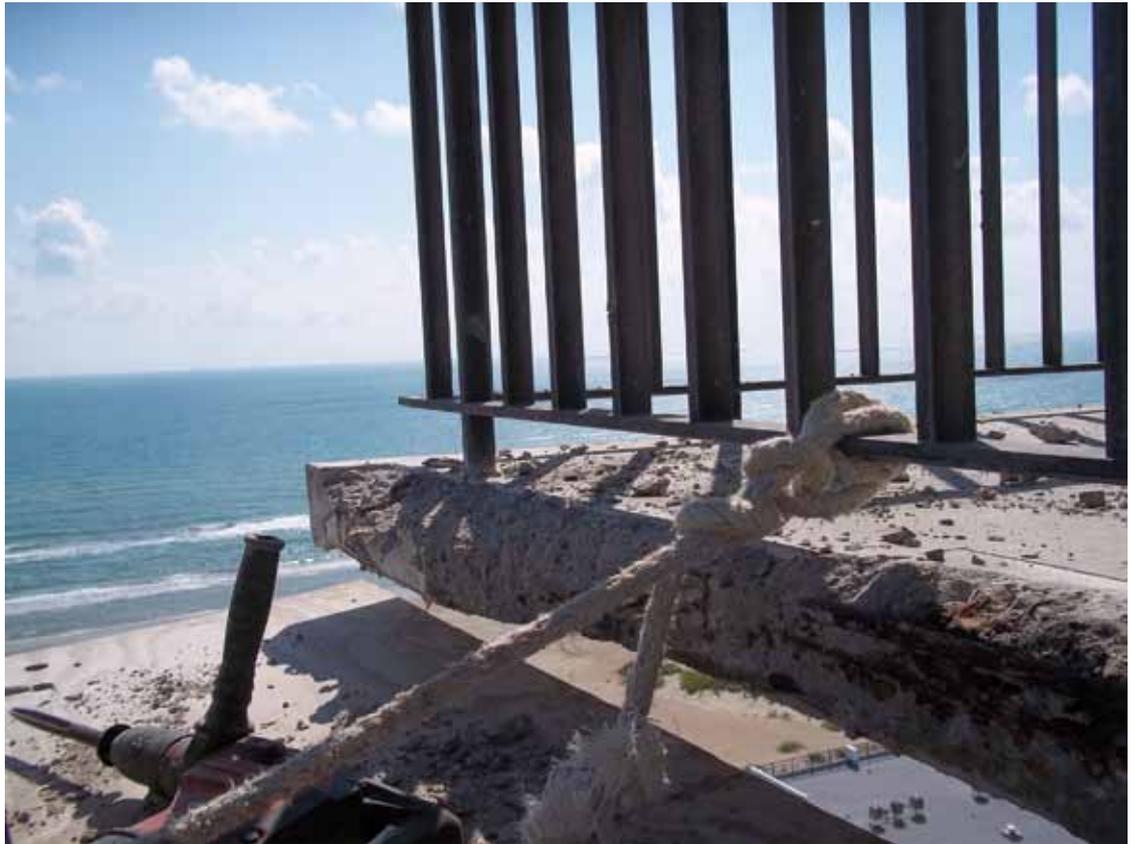
*Concrete being removed from balconies*

ICRI surface preparation guidelines were followed. All the deteriorated concrete was removed until sound concrete was exposed. Surface preparation was done with concrete saw cutting and chipping hammers. Plywood was placed on the swing stage beneath the balcony to catch the small fragments. The deteriorated concrete was gathered by hand and placed into empty buckets on the swing stage, then lowered to the ground for disposal.

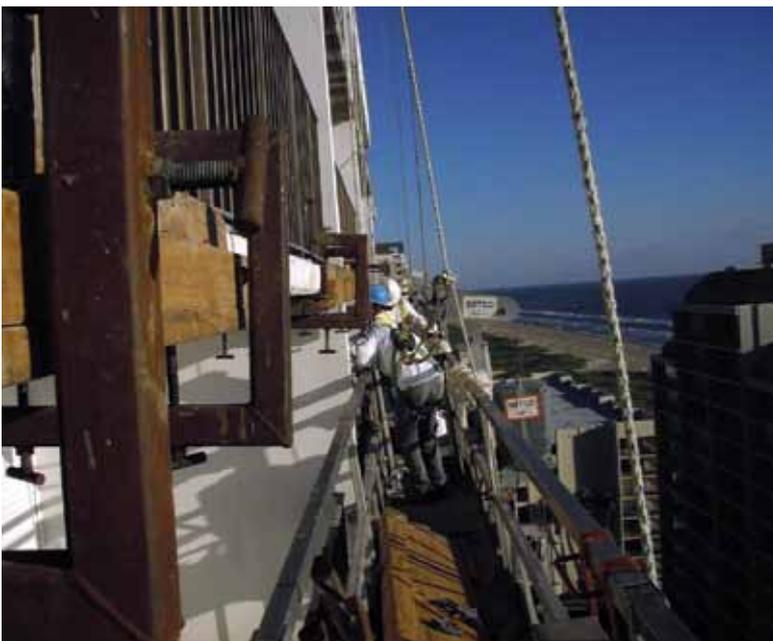
*Repair work accomplished using swing stages*

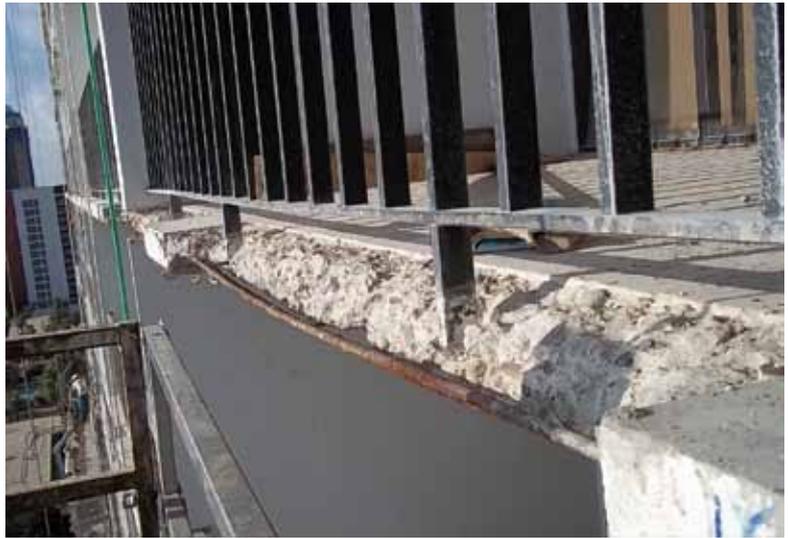
*Balcony ready for repair material*

All of the exposed steel was treated with a corrosion inhibitor to protect the steel and also act as a bonding agent for the form-and-pour repair material. Anodes were used in strategic locations to provide additional cathodic protection in the high-chloride environment.

The repair material was mixed on the swing stage using an electric mixer. A fluid repair material was selected for the formed horizontal work. The material chosen had an acceptable ohm value so it did not interfere with the current of the cathodic anode. A trowel-applied material was selected for vertical and overhead applications. A liquid, film-forming curing compound was used immediately after the forms were removed to help minimize the effects of the hot weather.

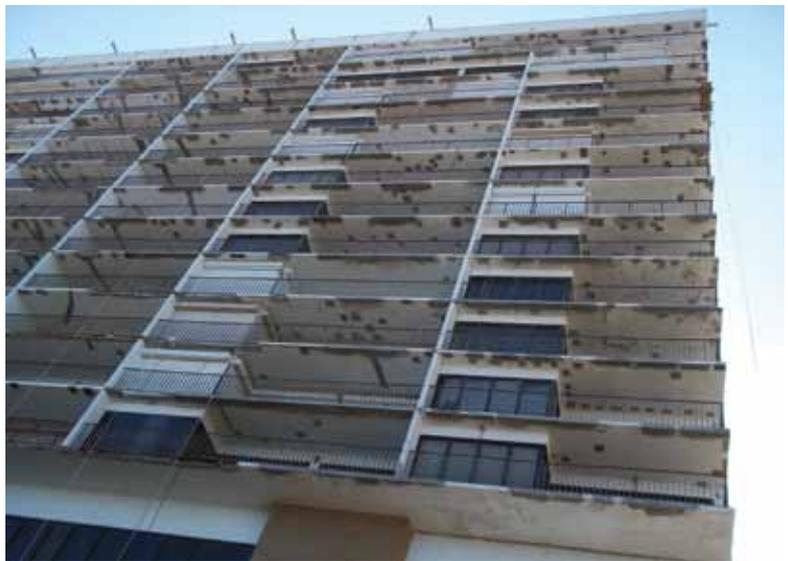
*An extensive amount of concrete repairs were required for the balcony edges and soffits*

Overhead repairs were made to the underside of every balcony where reinforcing steel support chairs had rusted.

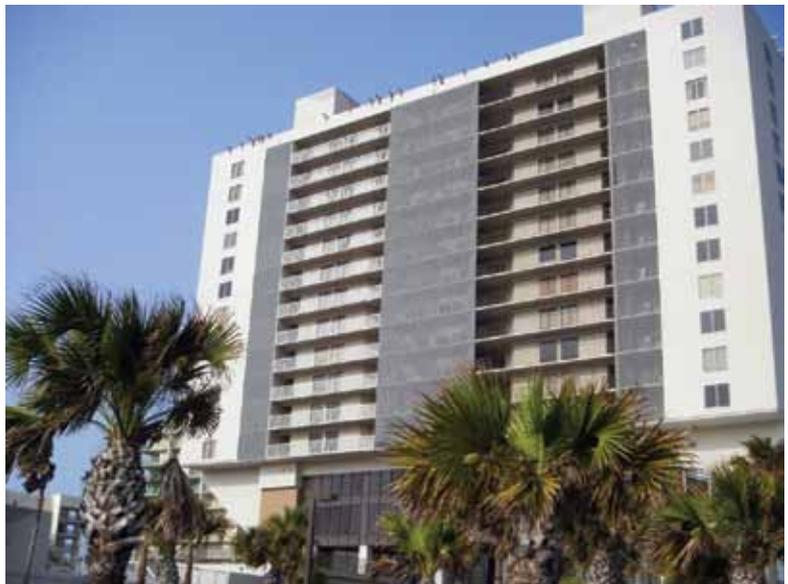
*Completed project*

Two coats of a waterproofing coating were placed on the balconies, terminating on the bottom of the slab drip edge. An elastomeric coating was applied to the vertical surfaces for aesthetic purposes. Fog commonly caused delays during the application of both types of coatings. On several occasions, it took until mid-afternoon for the extremely moist fog to be burned off by the sun and conditions to become dry enough for the coating to be applied.

The final details of the project involved applying ceramic tiles on the balconies and installing side-mount railings, which were necessary because the specified cored-in-place railing mounts could have damaged the post-tensioned strands.
