FIRE DAMAGE EVALUATION AND REPAIR OF PRECAST CONCRETE GARAGE

The evaluation of the extent of damage a concrete structure may have sustained from a fire, as well as the adequacy of affected members to remain in service, involves a systematic assessment of post-fire conditions. This article describes an evaluation of fire damage and subsequent development and implementation of repairs to the Woodlands Waterway Marriot Parking Garage located in Spring, TX.

Woodlands Waterway Marriott Parking Garage Evaluation and Repairs

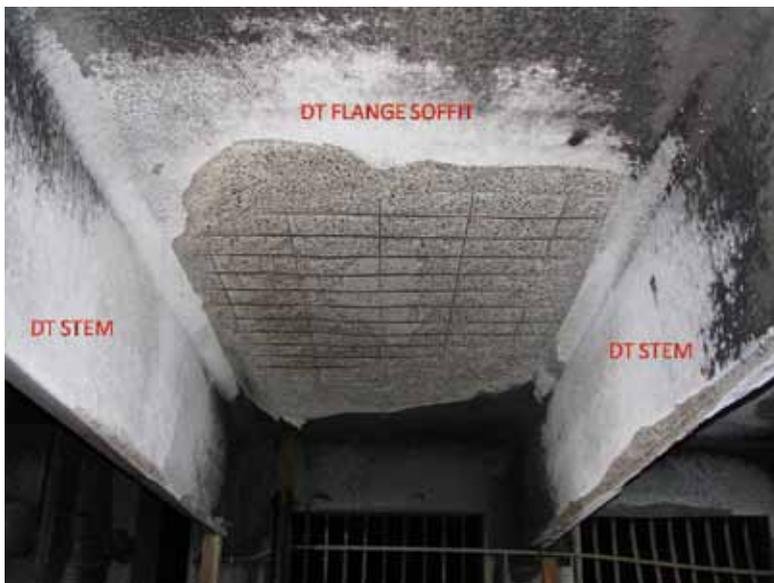
Detailed field observations revealed localized concrete spalls, cracks, and delaminations in the double tees, haunches, and wall panels. The most severe distress occurred in the double tee stems and flange soffits (Fig. 1). The flange soffit spalling was generally less than 1 in. (25 mm) and exposed portions of embedded welded wire reinforcement. Longitudinal spalls were noted at the corners of the stems, and lengths up to 10 ft (3 m) of welded wire reinforcement were visible. The spalls also exposed the bottom prestressing strand in several stems for lengths up to approximately 15 ft (4.6 m).

The spalling occurred due to the following material and structural response mechanisms¹:

1. **Thermal gradient:** During the early stages of the fire, rapidly heated double-tee flange surfaces expanded at a greater rate than the cooler underlying material, resulting in a significant thermal gradient and buildup of stresses near the surfaces. When the shear/tensile capacity of the concrete was reached, a failure plane developed and an outer layer concrete was disengaged.
2. **Restraint:** Upon heating, the surface concrete of the stem or haunches expanded in all directions. At corners, this thermal growth resulted in expansion from two orthogonal

Fig. 1: Double-tee flange soffit and stem affected by the fire

directions. This region of the corner was restrained by the relatively cooler, underlying concrete. Upon further heating, the tensile capacity of the concrete near the corner was reached, and cracking or expulsion of this portion occurred. A series of cracks, typically 1 to 3 in. (25 to 76 mm) from the corners developed, as the thermally growing member “shed” its corners.

The spalled areas at stems, wall panels, and double-tee flanges were patched using conventional concrete repair methodologies. Patch repairs for corner spalls of the stems generally consisted of the removal of loose and unsound concrete, preparation of the exposed steel reinforcement, installation of stainless steel threaded rod anchors, and form-and-pour application of a polymer-modified portland cement-based patching material. The perimeter of the patch was saw cut to avoid feather edges. In addition to the threaded rod anchors, longitudinal threaded rods were installed along the corner spall repairs to control shrinkage cracking of the patch material. The spall repair at the flange soffit was accomplished using low-pressure spray-applied mortar (Fig. 2). Trowel-applied and form-and-pour repair techniques were considered; but given the overhead application, it was felt that the low-pressure spray technique would provide a higher level of assurance because the repair material was bonded to the sound concrete. Exposed steel reinforcement was cleaned by wire brush/hand methods and coated with an epoxy-modified cementitious material to improve bond with the repair material and provide enhanced corrosion protection.

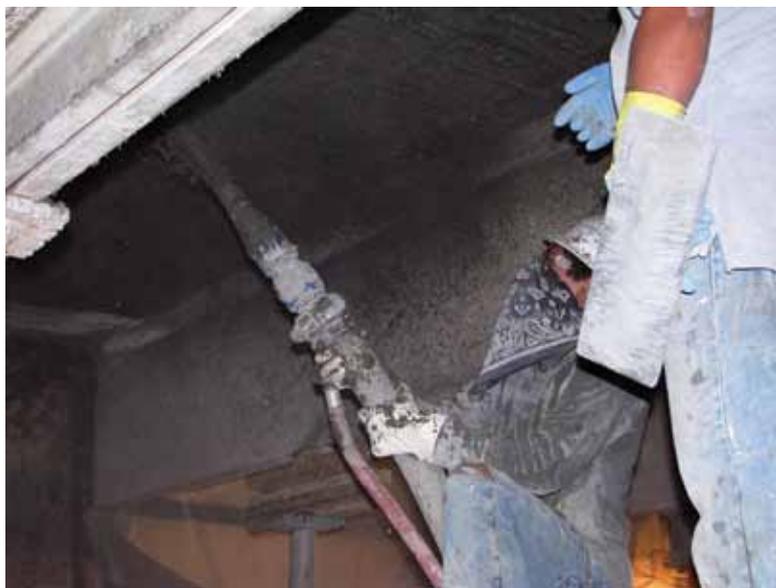
Fig. 2: Application of spray-applied mortar on double-tee flange soffit

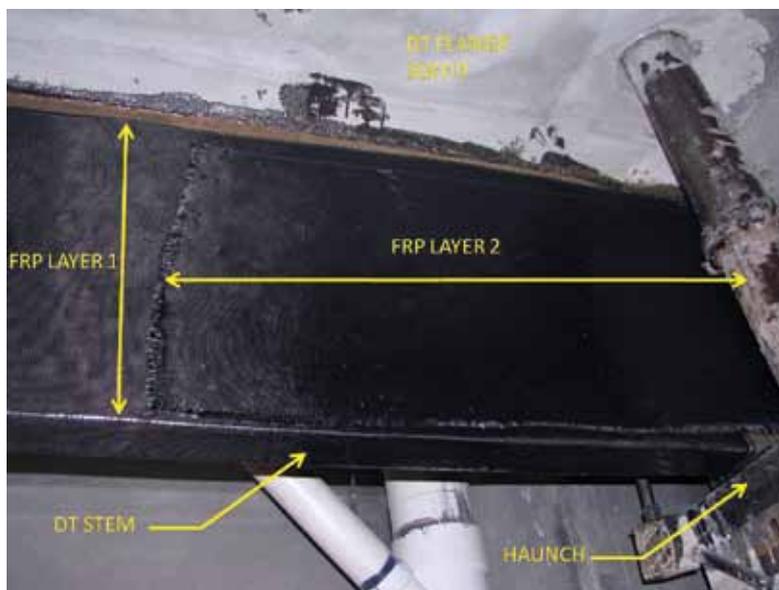
Fig. 3: Double-tee stem FRP repair

Design of the FRP system was performed following guidelines presented in ACI 440.2R-08.² Two plies, or layers, of a bidirectional carbon FRP system were used. The first layer consisted of a “U-wrap” configuration along the portion of the stem located approximately 15 ft (4.6 m) from

the support. This layer provided the necessary supplemental shear capacity. The upper end of the fabric was extended to within several inches of the flange soffit. In addition to providing the shear capacity, the fabric also served to confine the repair material for the corner spalls. The second layer consisted of a short section of fabric placed at the end of the stem. This layer was oriented in a plan view “U-shaped” configuration such that it extended around the end of the stem (Fig. 3 and 4) and for 3 ft (0.9 m) on each face toward the midspan of the member. The purpose of the second layer was to provide supplemental strength to a localized region of the stem exhibiting more extensive cracking.

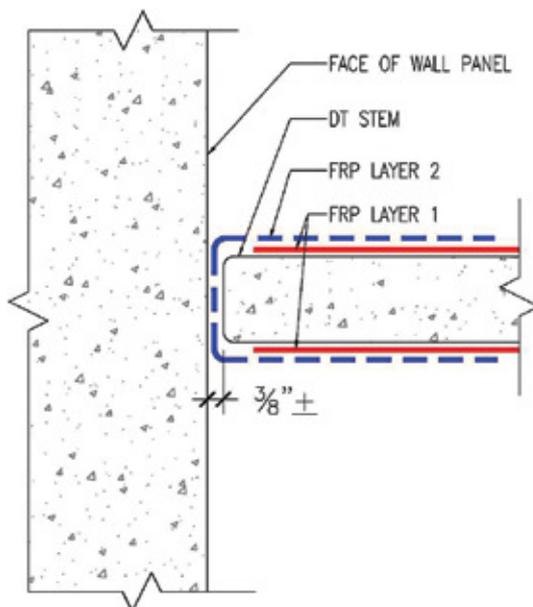
Fig. 4: (a) Schematic plan view of end of double-tee stem showing FRP layers; and (b) installation of FRP Layer 2

7. The first layer of FRP was installed and pressed into place.
8. The second layer of FRP was installed immediately after the first layer. Epoxy adhesive was applied to the end of the stem prior to the application of the second layer. Due to the tight gap between the end of the stem and the face of the wall, a sacrificial FRP extension wrapped on a piece of cardboard was used to facilitate pulling the FRP around the end of the stem.
9. All repaired areas were painted with acrylic-latex coating.
