HARRIS COUNTY ADMINISTRATION BUILDING

HOUSTON, TEXAS

SUBMITTED BY SIKA CORPORATION

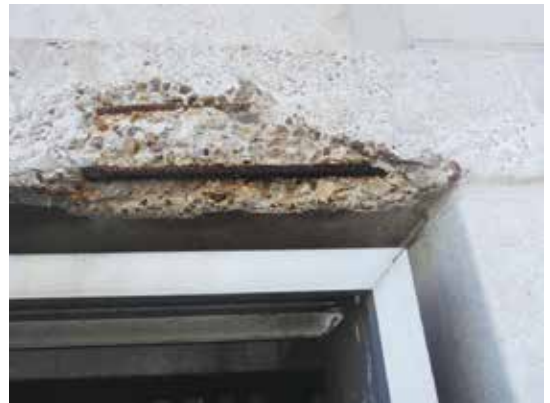
The HCAB has suffered from the results of poor construction practices since it opened 38 years ago. The reinforcing steel throughout the building was placed too close to the surface and generally poor workmanship allowed the elements of weather and time to deteriorate the structure overall. Most of the concrete members contained some degree of spalling (Fig. 2), cracking, and honeycombing (Fig. 3).

Fig. 2: Major spall due to rebar corrosion on building façade

being made off the swing stage. All cracks were filled with epoxy, utilizing pressure injection equipment. The surface bug holes were filled with an epoxy paste and the honeycombed concrete was repaired as well. The deep concrete spalls were repaired with a pre-bagged, cementitious, polymer-modified, self-consolidating concrete mix and the thin repairs were made with a pre-bagged, one-component, cementitious mortar designed for vertical and overhead repair.

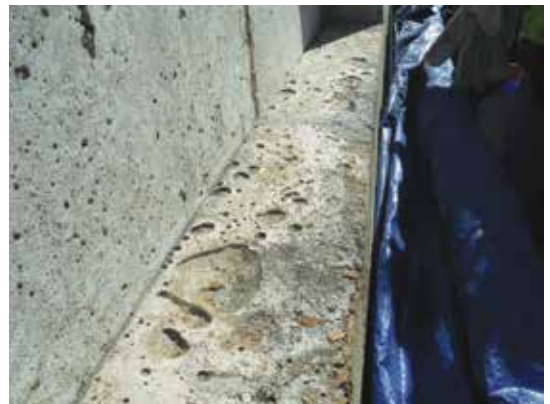
Fig. 3: Honeycombing damage on concrete beams

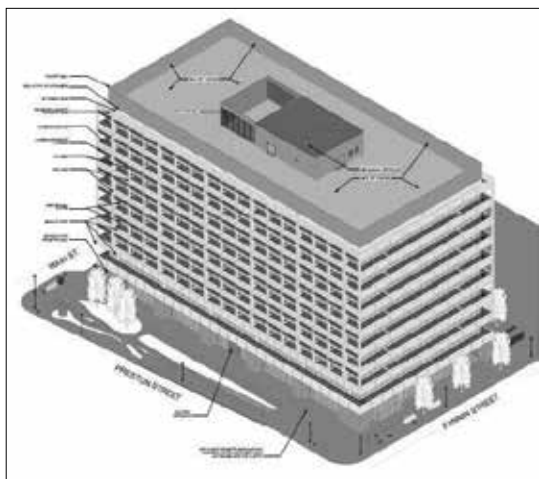
Fig. 4: Southeast isometric view of Harris County Administration Building

The entire exposed façade of 180,000 ft² (16,725 m²) was grinded as part of the surface preparation requirements (Fig. 4). Pressure washing was allowed but the City of Houston did not allow any runoff into the storm sewers. Instead, a collection basin was set up on the first floor and water was gathered and vacuumed into a water tanker. The original engineer's estimate called for only 400 ft (120 m) of cracks to be epoxy injected. However, it became apparent early on that this quantity was way off. Ultimately, over 12,000 ft (3660 m) of cracks were identified and epoxy injected, although no additional time was added to the schedule for this extra work.

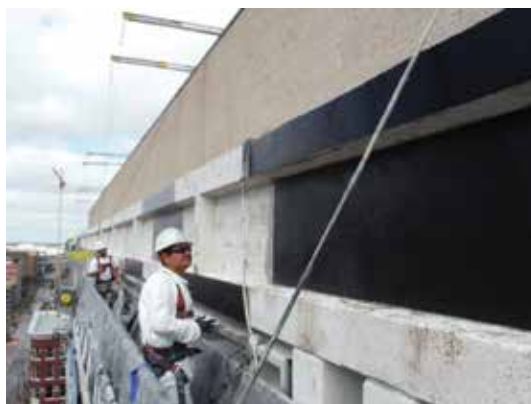
Fig. 5: Swing stage equipment used for CFRP repairs

All repairs made on the exterior of the building were accessed from swing stage scaffolds (Fig. 5 and 6). The challenge for the erection of the swing stage was the presence of an oversized parapet wall on the roof which was 12-15 ft (3.7-4.6 m) tall. Scheduling and sequencing of the work was critical to remain on schedule because different repairs were

corners between the sunshade and outrigger beams where cracking was prevalent (Fig. 7) A double-bias, +/- 45 degree CFRP fabric was installed on both the interior and exterior faces of the web to provide shear reinforcement (Fig. 5 and Fig. 6). The finished fabric was then leveled off with a silica-fumed-enhanced epoxy resin and painted with a pigmented acrylic coating to complete the repair.

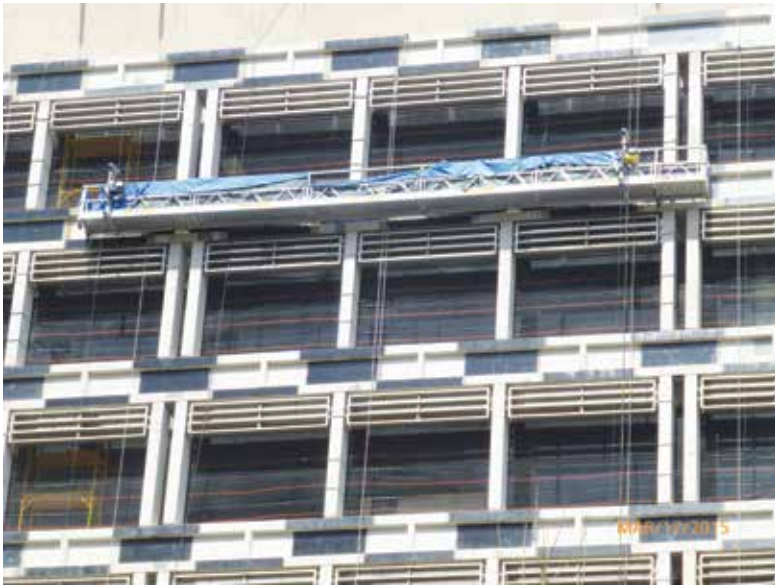
Fig. 6: CFRP fabric installation at exterior web faces

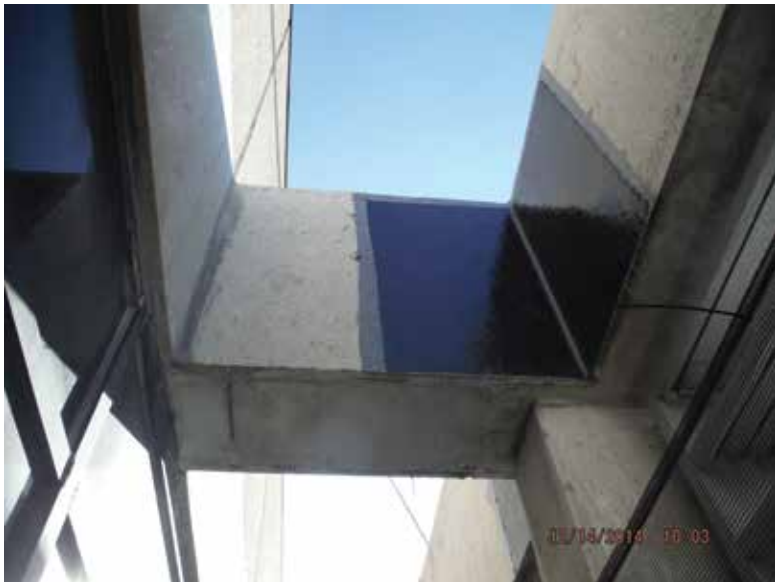
Fig. 7: CFRP repairs on sunshade beam flange and web

Once the concrete repairs were finished and allowed to cure, the carbon fiber reinforced polymer (CFRP) repairs were conducted. A unidirectional CFRP fabric was installed along the top and bottom flanges of sunshade beams for flexural strengthening. This same fabric (3 layers) was installed on the interior

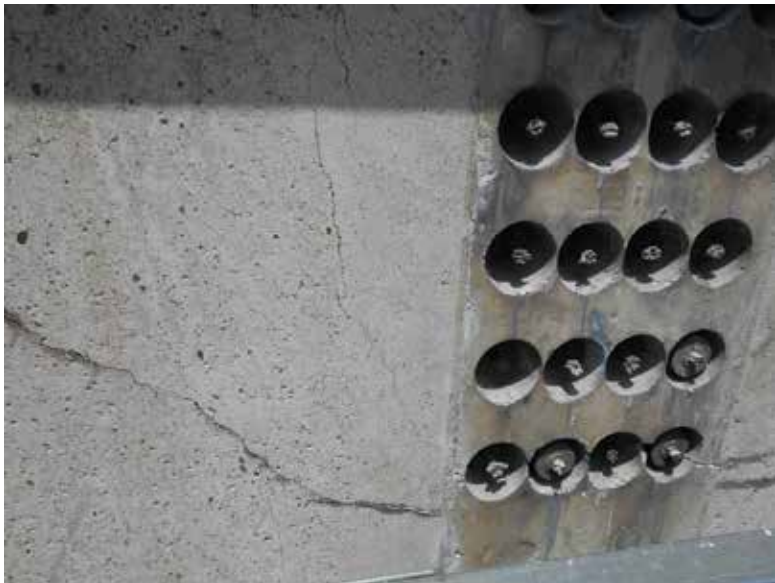
Fig. 8: Shear cracking at post-tensioned cable anchorage

The structural system for this building is a reinforced concrete frame. The floor framing consists of reinforced concrete slabs supported by post-tensioned concrete beams (Fig. 8), which in turn are supported on two rows of interior concrete columns on concrete piers. The post-tensioned beams cantilever beyond the window wall perimeter and function as outriggers to support the perimeter concrete sunshade system. The ends of the post-tensioned outrigger beams are fitted with precast

Significant corrosion was detected on the ends of the post-tension cables on the north and south elevations and also at the button head anchors located on the east and west elevations. All steel plates and button heads were exhibiting flaking paint and rust, as were the inside of the button head anchors. To repair these anchorage zones, the precast concrete caps were removed and steel rust was cleaned, repaired and painted with an anti-corrosion rust inhibitor. Carbon fiber repairs were made to strengthen the concrete that was overstressed and severely cracked. Finally, the caps were replaced with new concrete using a form and pour technique.
