CONCRETE REPAIR

Lee County Courthouse Foundation Stabilization and Structural Repairs

Giddings, TX

Submitted by Wiss, Janney, Elstner Associates, Inc.

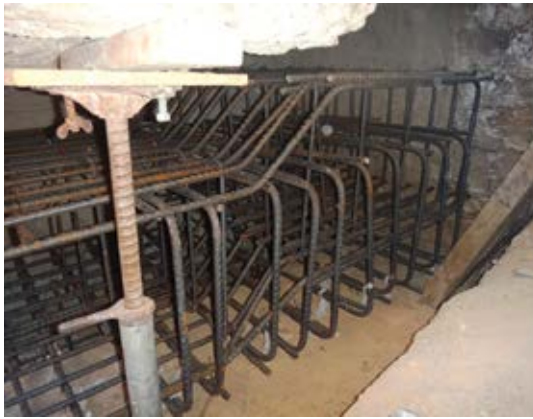
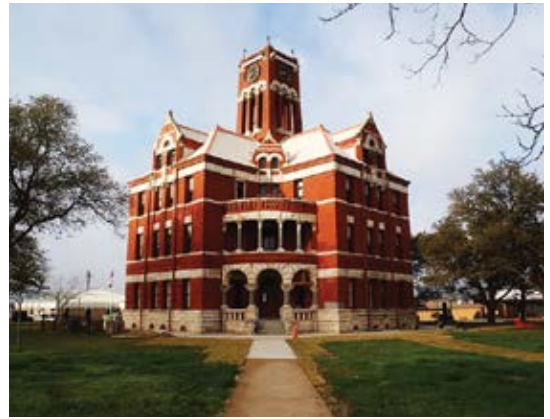
Lee County Courthouse

In 2008, cracks were noted in the plastered walls and load-bearing masonry. A geotechnical investigation confirmed that the majority of the distress was likely caused by the interaction of the underlying expansive clay soils that support the foundation. When the perimeter of the Courthouse was inundated with surface water due to poor drainage, the soil at the foundation edge heaved, whereas the central core remained stable. Stress cracking at the arched and perpendicular connecting masonry walls was a result of the movement and subsurface soil conditions.

To stabilize the perimeter foundation, a continuously reinforced, concrete, shallow spread footing was installed below the existing foundation. The existing storm-water drainage around the perimeter

of the Courthouse was revised to provide a slope of 2% away from the building. A perimeter trench was installed to capture surface water runoff and connect the roof downspouts. A French drain system was installed at the bottom of the existing footing; continuous around the perimeter of the Courthouse; and included new drain lines, filter fabric, gravel fill, and cleanouts. Furthermore, the subgrade waterproofing barrier was removed and replaced at the masonry walls below grade.
